SEEPAGE FLOW-STABILITY ANALYSIS OF THE RIVERBANK OF SAIGON RIVER DUE TO RIVER WATER LEVEL FLUCTUATION

A. Oya¹, H.H. Bui², N. Hiraoka¹, M. Fujimoto³, R. Fukagawa³

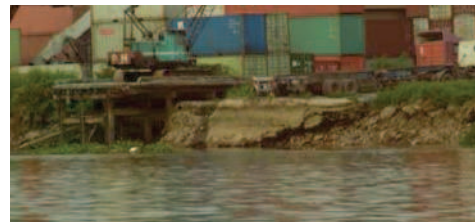
Figure 1 Riverbank failure along Saigon River

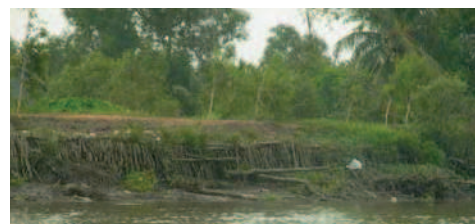
Examples of riverbank failure countermeasures currently in use along the Saigon River are shown in Figure 2. These include: wooden piles to structurally reinforce river banks, and soil bags as temporary reinforcement measures. However, reinforcement of large sections of the river with piles is likely to be prohibitively expensive, sandbags are at best of a practical short term solution; an effective and economical countermeasure is required. However, in order to identify effective countermeasures it is necessary to first develop an understanding of the mechanisms leading to riverbank instability and failure and their causes. Investigating riverbank failure mechanisms has been a focus of our research group. The river water level fluctuation has been identified as one of the main factors affecting the

Figure 2 Countermeasure by wood piles

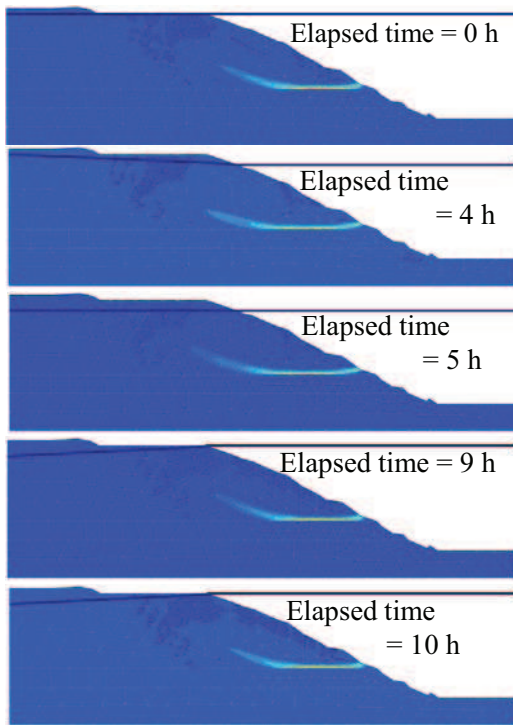
For the analysis for No.1 (profile A-A'), results are shown in Figure.15 as potential failure surface obtained by stability analyses. The blue lines show

Figure 15 Potential failure surface on profile A-A'

the estimated the phreatic level in the ground. Safety factors are plotted in Figure 16 with river water level. When the water level goes down, the safety factor is lower. The riverbank slope is stable because of hydraulic pressure from the river when the water level remains high; however, when the river water level goes down, the hydraulic pressure dissipates and the slope becomes unstable. When the phreatic level in the river water level goes down, the phreatic level in the ground remains at a high level because of the ground's low permeability, and the weight of the soil remains high. It can be assumed that this leads to the instability of the slope. Furthermore, potential failure surface occurs in deeper point in lower water level stage, which indicates more massive slope failure can occur in this situation.

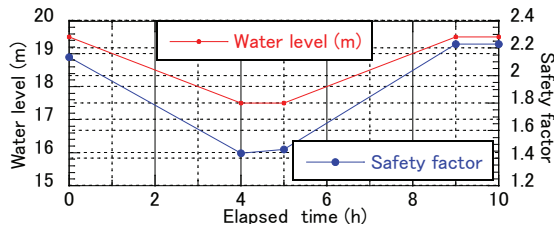
Figure 16 Safety factor on profile A-A'

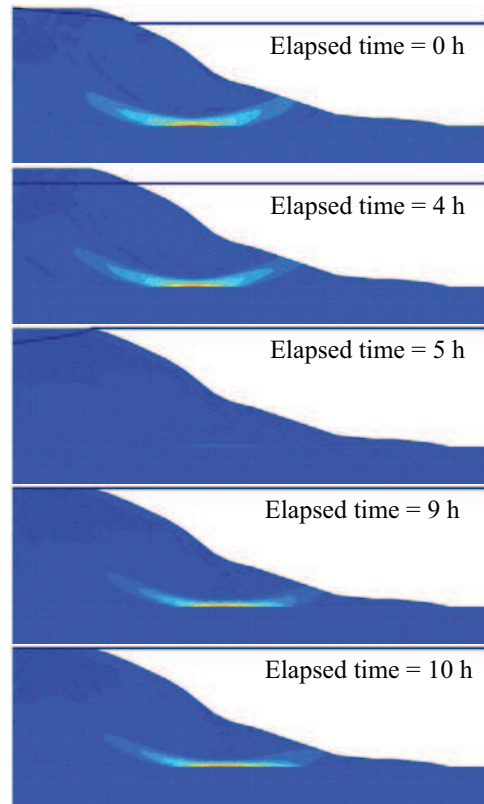
As for the analysis for No.2, results are shown in Figure 17 as potential failure surface obtained by stability analyses. The blue lines show the estimated the phreatic level in the ground. Safety factors are plotted in Figure 18 with river water level. At 5h, the water level ascent period, significant slip surface does not appear. In other stage of analyses, failure surfaces are observed on the boundary between layer

Figure 17 Potential failure surface on profile B-B'

1 and 2. A safety factor value under 1.00, which indicates the slope is unstable, is estimated in the period of water level descent. The maximum safety factor value of the slope at B-B' is lower than any safety factors of the slope at A-A' and C-C'. From the aforementioned factors, the slope is originally unstable, and gets more unstable due to water level descent.

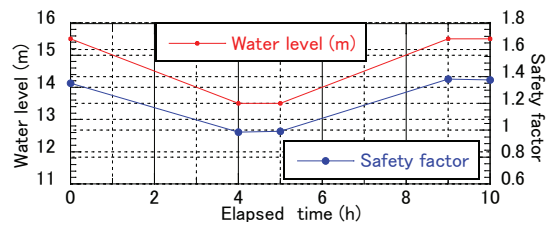
Figure 18 Safety factor on profile B-B'

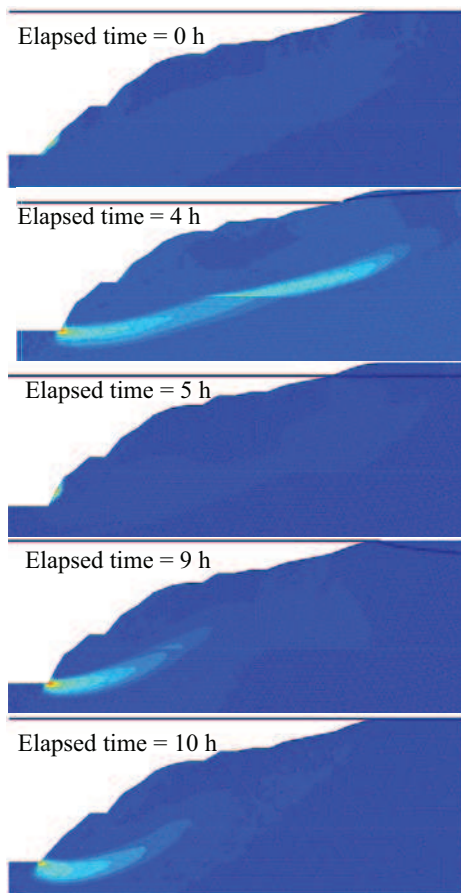
The results of the analysis for No.3 (profile C-C') are shown in Figure 19 as potential failure surface obtained by stability analyses. The safety factors of the bank estimated stability analyses are shown in Figure 20. The safety factor of the bank falls when the water level decreases and remains low, as is the case with profile A-A'. The phreatic level remains higher than the river water level, which is assumed to be the cause of the instability of the slope. The difference in safety factors for water level decent, the low water level

Figure 19 Potential failure surface on profile C-C'

period, water level ascent and the high water level period is smaller than that of other points analyzed. This is because the height of the slope is bigger than other points. As for slip surfaces, significant ones do not appear when a water level is constant such as elapsed time 0 h and 5 h. On the other hand, 2 failure surfaces on the boundary of layer 1 and 2 and toe of the slope can be observed at elapsed time 4 h. There is a possibility that most massive slope failure occurs in this period.

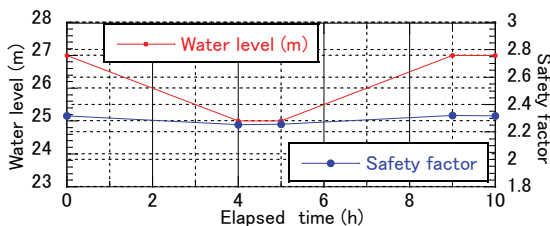
Figure 20 Safety factor on profile C-C'
