DESIGN, MANUFACTURING, ASSEMBLY, AND LESSONS LEARNED OF THE PRE-PRODUCTION 325 MHz COUPLERS FOR THE PIP-II PROJECT AT FERMILAB *

Five 325 MHz high-power couplers will be integrated into the pre-production Single Spoke Resonator Type-II (ppSSR2) cryomodule for the PIP-II project at Fermilab. Couplers were procured by both Fermilab and IJCLAB for this effort. The design of the coupler is described, including design optimizations from the previous generation. This paper then describes the coupler life cycle, including design, manufacturing, and assembly, along with the lessons learned at each stage.

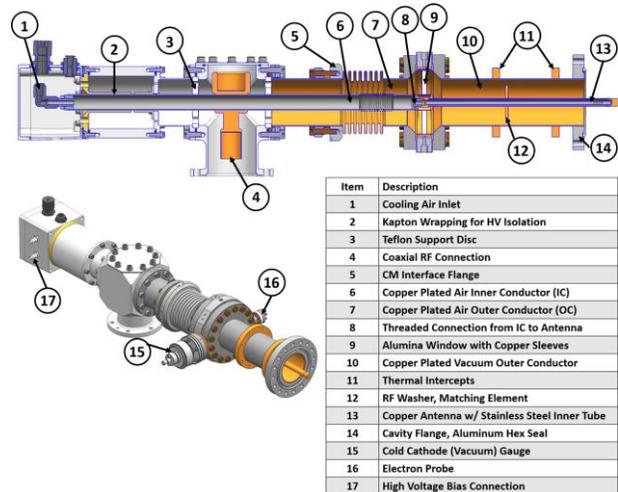
The critical design components of the ppSSR2 coupler are shown in Fig. 1.

Figure 1: The full ppSSR2 coupler assembly.

A single alumina ceramic window separates the beam-line volume from atmosphere. The window is brazed to pliable copper sleeves which allow for thermal expansion without undue stress. The copper antenna contains an internal stainless steel (SS) tube which provides cooling air and additional stiffness necessary for transportation and handling. TiN coating was applied to several of the alumina windows, and the results are discussed separately [7]. A high voltage (HV) bias of 3.5 kV is maintained during operation between inner conductor/antenna and the outer conductor, resulting in suppressed multipacting activity. The antenna tip is symmetric and fixed, and so Q_{ext} is not adjustable.

The antenna assembly, cold outer conductor (OC), air inner conductor (IC), and air OC were all designed to be furnace brazed. The cold OC is plated with 12 microns of OFHC copper to reduce RF losses.

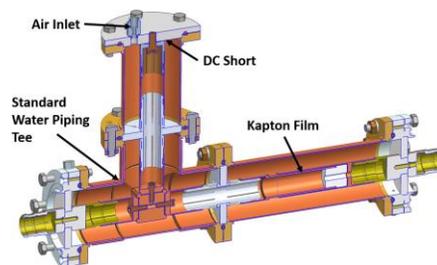
The DC Block, shown in Fig. 2, serves to isolate the coupler input and protect the RF amplifier from HV bias.

Figure 2: DC Block Design

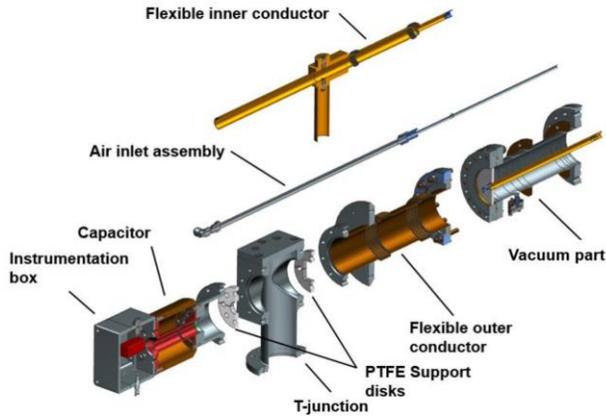
The pSSR1 coupler design [4] is shown in Fig. 3. The following is a summary of the major design changes implemented on the ppSSR2 couplers: air inlet tube changed from removable to fixed, air outer conductor has a single bellow and is copper plated, the ceramic disk stress relief sleeves were lengthened, the antenna flange uses ConFlat® sealing instead of 'diamond' seals, the E-Probe was moved to the vacuum OC flange instead of the tube, a vacuum gauge

Figure 3: pSSR1 Coupler Design [4]

was added, the vacuum OC wall thickness was increased to improve robustness, and copper plating was added to the vacuum OC. While most of these changes were inspired by the lessons learned from pSSR1 couplers, while others came from the 650MHz couplers [8] [9].

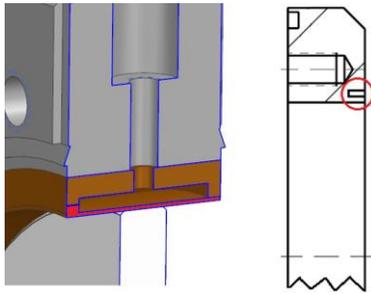
These changes required modification to the relevant interface designs, shown in Fig. 4. For the ceramic outer sleeve, extra material was added as a shoulder, which served to stiffen the part (better tolerances) and was better served to EBW. This design change would likely work well on a brazed assembly as well. One flange on the air side required an undercut next to the weld area so the welded parts would be of similar effective thickness.

Figure 4: Left: Update to window sleeve. Right: Update to Vessel Flange

Even though the vendor is specialized in metal and metal-ceramic brazing, and owns a large range of brazing furnaces, some alternative solutions to brazing were chosen. Electron beam welding (EBW) was used to connect the brazed antenna to the TiN coated ceramic window sub-assemblies since TiN can’t tolerate brazing temperatures. Several air parts were laser welded including the flange-tube connections and the bellows-tube connections. TIG welding was used for small flange-tube connections on the VAC OC. These changes were done to reduce cost and avoid delays since the vendor’s furnaces were occupied with other large scale production jobs.

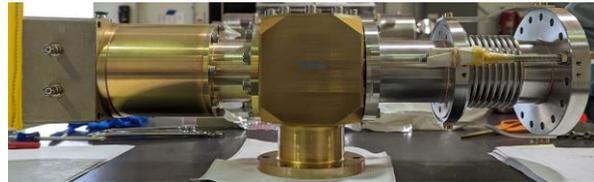
The quality of the air side coupler components, shown in Fig. 5, was excellent, with very few issues found. The copper plating was adherent and free of defect, the brazes were of good quality, and individual parts conformed to the relevant drawings and specifications. The only major issue found was that the bellows outer conductors had inconsistent length due to varying levels of bellow compression/elongation. This issue was remedied via incremental stretching of the bellow and re-inspection of copper plating. Stretching was

Figure 5: Air Side Coupler Assembly

necessary as the bellow outer conductor interfaces with the vacuum vessel, and this interface location can’t be significantly moved. The inspection took place in an open-air workspace and followed written procedures.

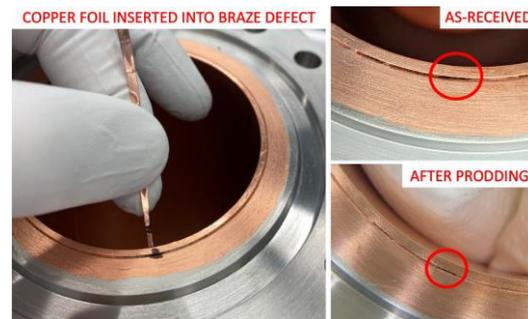
The quality of the vacuum side coupler components proved more problematic. The first two vacuum side units did not meet the specified cleanliness requirements, which was caused by a misunderstanding on the part of the vendor. Of the five couplers, two vacuum side outer conductors were found to have under-filled braze joints, which only had a blackened appearance at first. Prodding with thin copper foil (soft enough not to scratch, but firm enough to remove loose material) revealed that the defect was nearly half the depth of the brazed joint and 3-4 mm in width. Given the defect location (beamline vacuum space, facing into the cavity) the units were sent back for repair. It is thought that inspection prior to copper plating was insufficient. Additionally, discussion with the vendor found the length of the braze joint (12 mm) and flow orientation (cavity facing side was the end of the flow path) to be non-optimal. The inspection of vacuum side components took place in an ISO 4 clean room, and followed written procedures.

Figure 6: Outer Conductor Brazing Defect, Cavity Flange

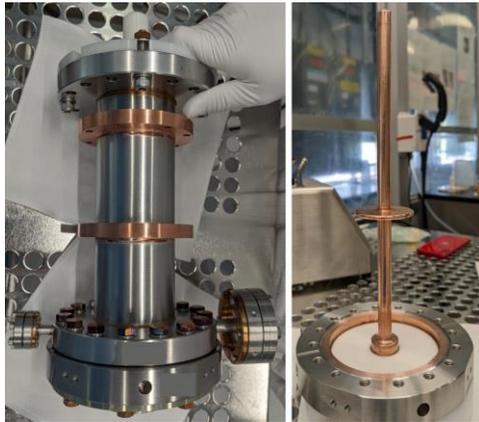
All other aspects of the vacuum side components met or exceeded expectations, including, but not limited to, shipping configuration, copper plating quality, general brazing quality, cleanliness (upon return to FNAL), and dimensional control. An accepted antenna and Vacuum OC can be seen in Fig. 8.

Figure 8: FNAL Accepted Components

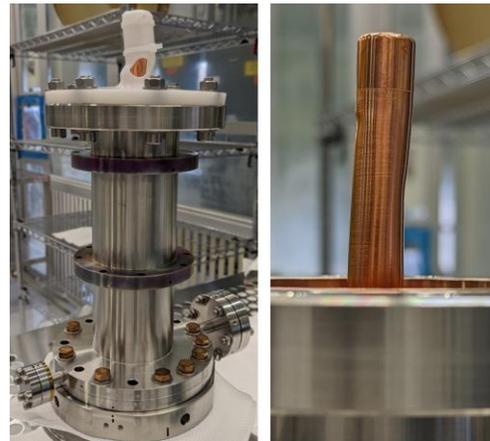
One of the coupler's antenna was found to be significantly bent, as shown in Fig. 9. As the stiff protective cover was also bent, it is hypothesized that the fully assembled and bagged coupler was dropped at the vendor's sub-contractor and not disassembled for inspection afterwards. The coupler

Figure 9: Damaged Antenna

passed leak check, and will be conditioned as-is on the test stand to determine any possible effects the damage has on RF performance.

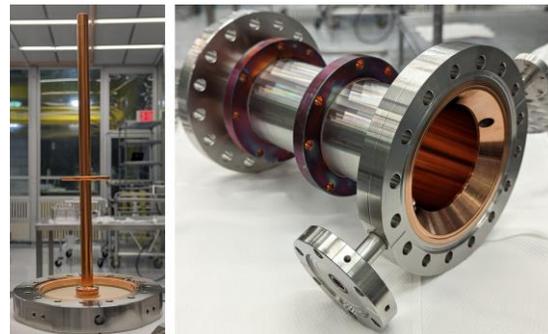
The overall quality of EBW and brazing was excellent. The exterior antenna surface exceeded expectations as the vendor had machined the antenna tube from solid stock instead of using the tube specified in the original design. The copper plating quality and lack of oxidation met expectations. Due to several small instances of damage to sealing surfaces, many of the components had to be re-cleaned. However particle counting found the UHV areas of the parts in compliance with requirements. Fig. 10 shows the non-damaged antenna and a Vacuum OC.

Figure 10: IJCLAB Accepted Components

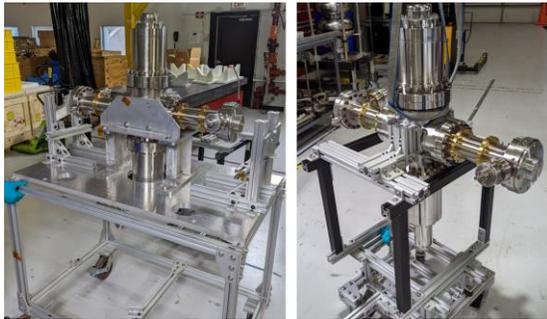
After components passed visual inspection and particle counting, the assembled couplers were installed to the RF test chamber shown in Fig. 11. When assembled, the antenna has a 3 mm radial gap to the capacitive coupling tube which the antenna is centered within. This assembly is performed by hand with the assistance of two technicians. The clean stand has minimal features near the coupler connection to minimize flow turbulence during assembly. Unfortunately, the very bent antennas could not be used with the current stand components, as they made physical contact with the capacitive coupling tube, preventing the use of HV bias during testing.

Figure 11: Left: RF Stand, Right: Clean Stand

Once out of the clean room, the chamber assembly is lifted and placed into the RF Stand cart. This is then transported to the onsite baking facilities, where the entire cart assembly is baked at 120 C for 48 hours while under vacuum. Residual gas analysis (RGA) scans are taken before and after 120 C baking to confirm lack of contamination and appropriate partial pressures.

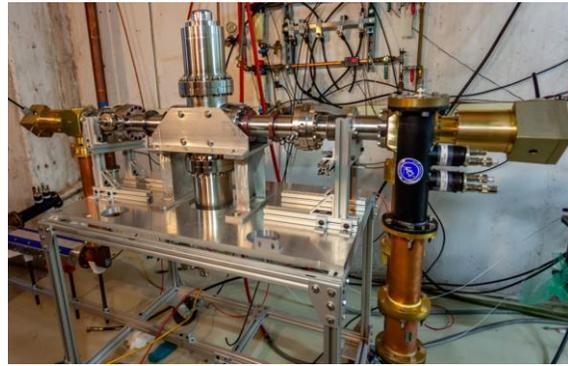
Once transported to the RF testing facility, the air side couplers and RF Coaxial lines are assembled, as shown in Fig. 12. The air side is supported by frames which mimic the cryomodule interface. Discussion of RF testing and the associated results are not within the scope of this article, but can be found in [12].

Figure 12: Assembled RF Test Stand
