Experimental and numerical analysis of a full-scale timber-concrete-composite beam from simply supported to frame-connected.

Authors: Dolores Otero-Chans, Félix Suárez-Riestra, Emilio Martín-Gutiérrez, Javier Estévez-Cimadevila

Affiliation: Universidade da Coruña, GEA-GEM, ETSAC, Centro de Innovación Tecnolóxica en Edificación e Enxeñaría Civil (CITEEC). Campus de Elviña, 15071. A Coruña, Spain/España.

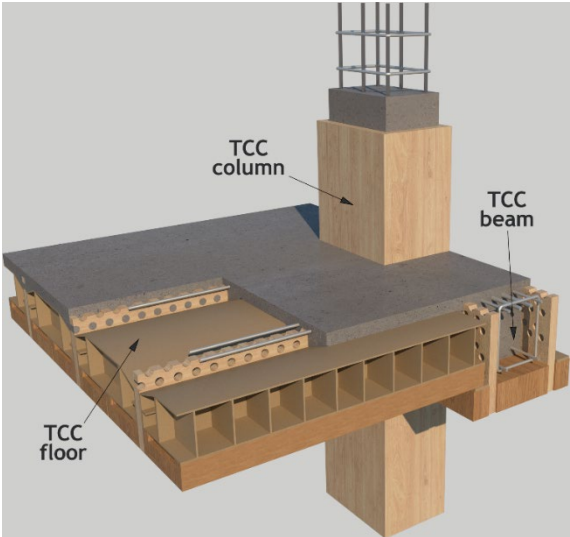
Fig. 1 Global timber-concrete system. Includes TCC supports, beams and floors.

Our research team proposed a structural system in which all the elements (supports, beams and floors) are designed using the TCC solution based on the shear connection made by means of holes drilled in plywood boards [24]. This would make it possible to take advantage of the continuity effect of concrete and to design joints with high moment carrying capacity in all connections between structural elements (Fig. 1). In this way, due to the increased bending stiffness and lateral stability of the system, the required cross-sections for the structural elements could be reduced compared to simply supported systems and additional bracing systems to resist lateral actions could be dispensed with. In previous articles, the flexural behaviour of simply supported floor elements with spans between 6.2 and 8.6 m [15] and cantilever elements [25] was studied. This paper shows the results from an experimental full-scale and numerical analysis of a simply supported beam and a beam connected to end supports forming a frame (frame-connected beam), carried out with the perforated board shear connection system. The increase in stiffness of the solution with semi-rigid beam-to-column

In the case of the frame-connected specimen, the beam was connected at each end to two 1350 mm long supports. This support length represents half the usual height between floors and corresponds to the approximate location of the null moment point under the usual hypothesis of gravity actions. The supports consisted of an outer box made of 40 mm thick birch plywood boards, in which circular notches had been made in a pattern similar to the holes drilled in the beams (Fig. 3). These boxes are designed to act as support and prompt for the beams during the assembly process of the structure and, after incorporating rebars, the fresh concrete is poured into them, generating the continuous connection of the system. In the case of a real building, the reinforced concrete also forms a continuous connection between the beams and the different floor elements (Fig. 1).

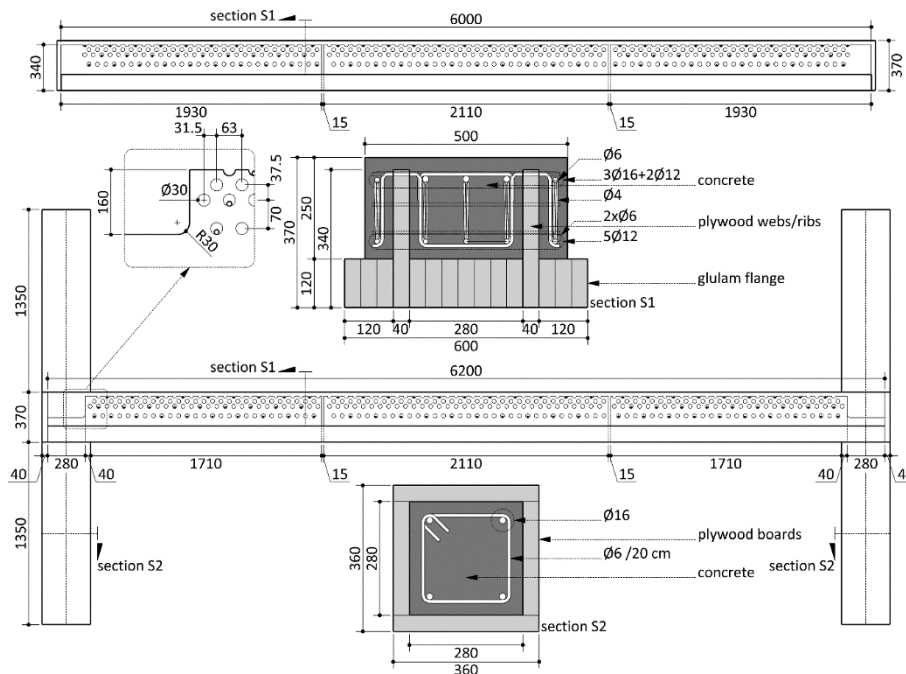
Fig.2 Dimensions of the beams and the supports.

A simply supported beam (SS) and a beam connected to upper and lower support portions forming a frame, called frame-connected beam (FC), were constructed to be tested. The total length of the simply supported beam specimen was 6.0 metres, to be tested with a 5.9-metre span between supports. The frame was designed with a 5.9-metre span between support axes for comparison with the simply supported beam.

Transversally, 8 mm diameter rebars were placed across the holes drilled in the boards, in order to increase the ductility of the shear connection, as observed in previous characterisation tests of these connection system [14]. The distribution of these bars, whose density increases in the extreme thirds of the beams, can be seen in Fig. 2.

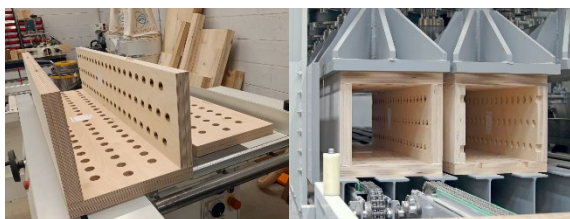
Fig. 3 Manufacturing process of the plywood board boxes that make up the outer layer of the TCC supports.

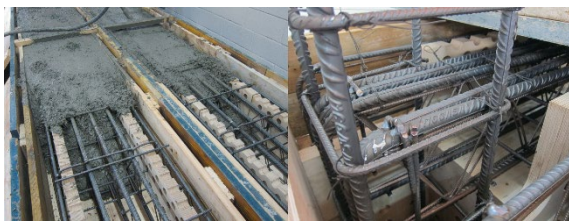
Fig. 4 Concrete pouring in simply supported and frame-connected beams.

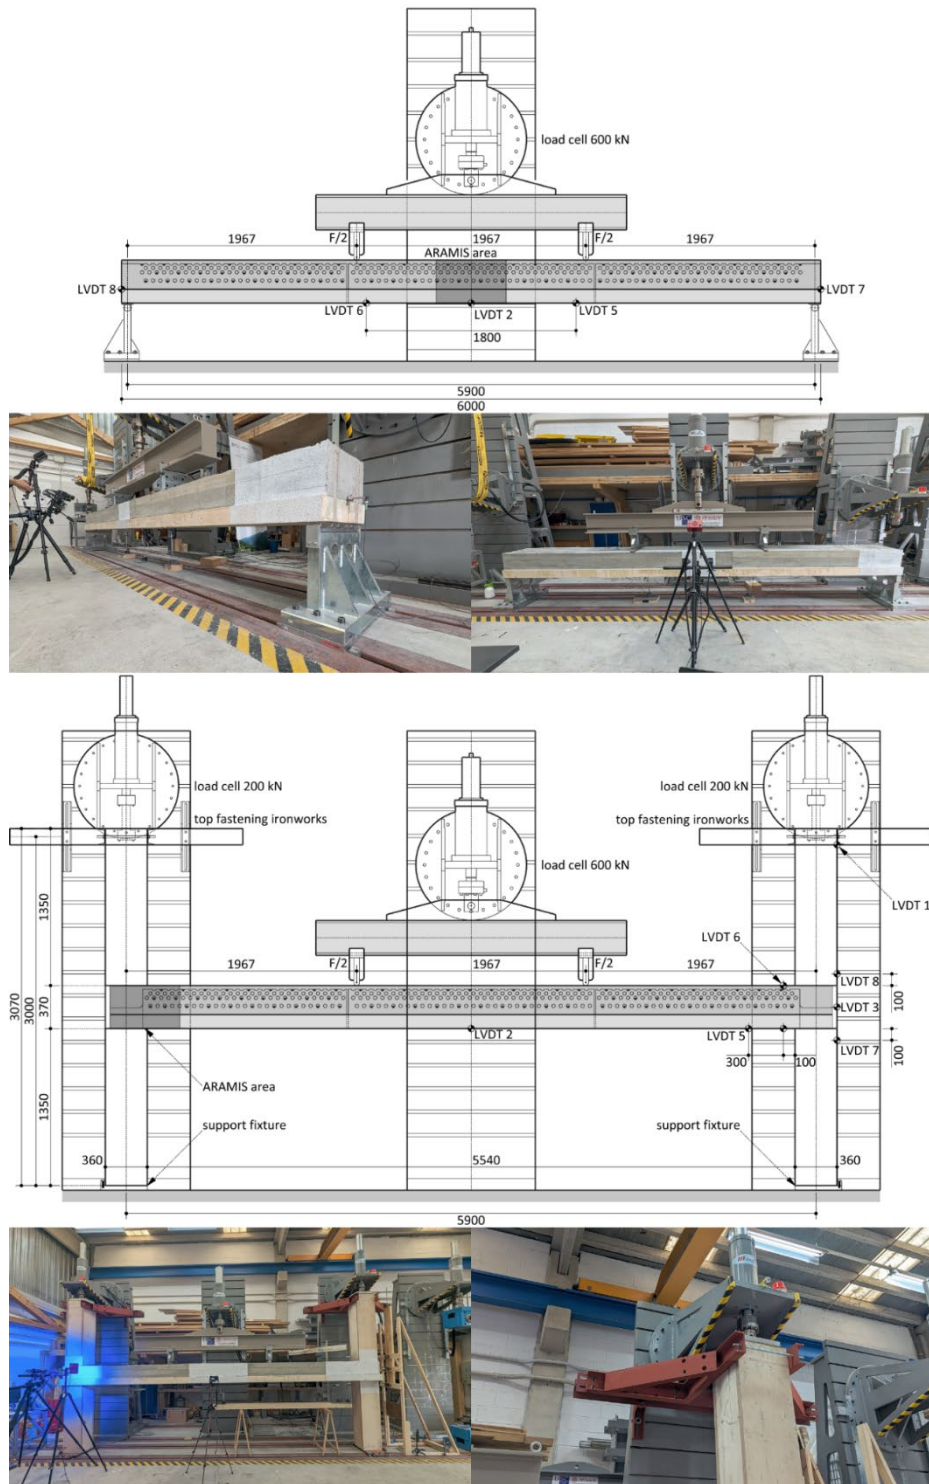
Fig. 5 Test set-up for the simply supported (SS) beam and the frame-connected (FC) beam.

Specimens were tested in bending in a four-point bending test configuration. The tests were carried out in the PEMADE laboratory of the University of Santiago de Compostela. A PB2-F/600 Microtest hydraulic machine was used. In the case of the frame, three load cells were used. Two of them, with a capacity of 200 kN, were used to apply load on the supports. The third, with a capacity of 600 kN, was used to apply the load on the beams. The loading was carried out by displacement control. The loading speed was adjusted so as not to exceed 2-3 minutes in duration for the non-destructive tests and 5-7 minutes in duration for the failure tests. The simply supported beam specimen was arranged over steel members with a span of 5.9 metres. A steel profile was used to distribute the load to two application points arranged at thirds of the span. Fig. 5 shows the arrangement of LVDT displacement sensors, three to

In the case of the frame specimen, connecting fittings were provided at the base of the supports to prevent displacement but allow rotation (Fig. 5). To fix the head of the supports, a series of triangulated steel profiles were provided linked to the sides of the load cell support. This top connection system could not guarantee the total absence of displacement at this point, so LVDT1 was used to record the lateral displacement of the support head. For the frame test, a total of 8 LVDTs were provided, distributed as shown in Fig. 5. The six tests performed for the simply supported beam were repeated, using the same maximum load values given in Table 1. Test FC1 was performed with no load on the supports. Test 2 was carried out firstly without

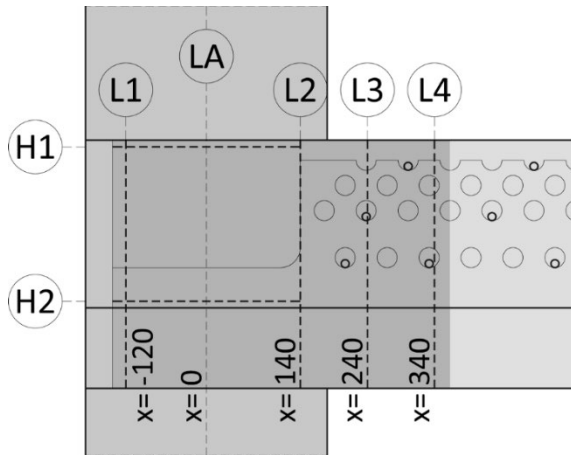
Fig. 6 Sections analysed with DIC.

In the case of the frame-connected beam, the behaviour of 7 lines/sections corresponding to the support axis (LA), 4 lines parallel to it at different distances (L1 to L4) and two horizontal sections near the top (H1) and bottom (H2) of the intersection between the support and the concrete area of the beam were analysed (Fig. 6). From the data recorded with Aramis, the rotation of the sections in the concrete area was determined for the different tests and loading stages. The rotations, expressed in radians, are subsequently included in Tables 5 and 6.

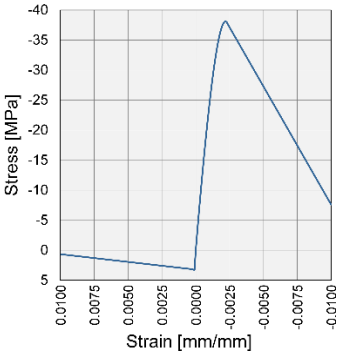
Table 2
Concrete properties used in FEM model according to [32]:

Property	Value	Reference
Compressive strength	38.1 MPa	f_{ck}
Young's modulus	34796 MPa	E_c
Mean tensile strength	3.396 MPa	f_{ctm}
Biaxial compressive strength	44.268 MPa	f_{2c2}
Dilatancy Angle	30°	ψ
Strain at peak compression	0.0024	ϵ_{cm}
Plastic strain at peak compression	0.0013	K_{cm}
Ultimate plastic strain in compression	0.01	
Relative stress at nonlinear hardening	0.40	
Residual compressive relative stress	0.20	
Plastic strain limit in tension	0.01	
Residual tensile relative stress	0.20	
Constitutive law according to Menetrey-Willam model

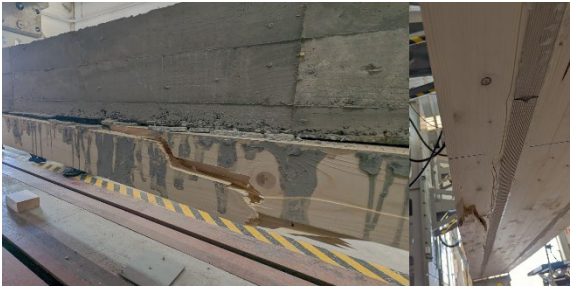
Fig. 7 Failure of the simply supported beam in the lower glulam flange.

The failure of the beam occurs for a load value of 432.80 kN. During the SS5 test, some cracking was recorded for loads above 180.0 kN, but no external damage was visible in the specimen. During SS6 (failure test), small cracking sounds were heard at loads above 270.0 kN, which continued until the specimen failed. The failure was caused by tensile failure of one of the glulam bottom flanges, which materialised as a brittle failure of the member. As can be seen in Fig. 7, the failure generated a longitudinal crack in a large part of the flange, but in no

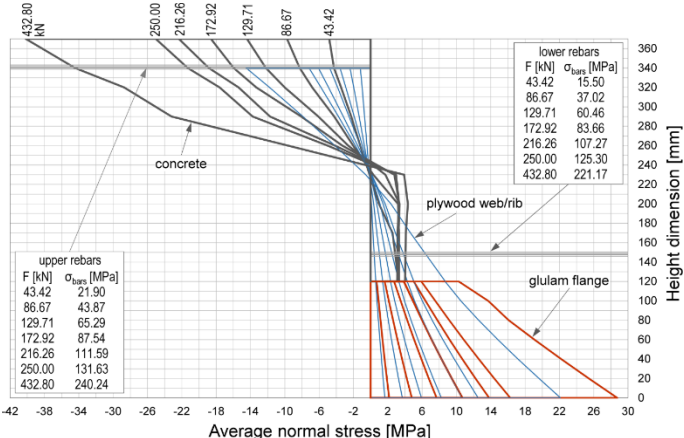
Fig. 8 Average stress distribution in the midspan section of the simply supported beam, obtained from the FEM model for different load values. Concrete in black, glulam bottom flange in red and plywood boards in blue.

Fig. 8 shows the distribution of normal stresses in the section corresponding to the midpoint of the beam. These values were obtained from the finite element model (FEM) by averaging the stress values at the different layers of the cross-section. In order to avoid the stress peaks that occur in the numerical analysis, layers or strata were defined and the average stress values at the different levels were determined for each material. The stresses corresponding to the upper and lower longitudinal reinforcement bars are not plotted in their total value in order not to reduce excessively the scale of representation of the stresses on the timber and concrete, but their value is indicated in the figure for the different load stages considered. At the moment of maximum ultimate load, the average stress in the upper reinforcement bars is 240.24 MPa and 221.17 Mpa in the lower reinforcement bars, which indicates that they remain in their elastic range in all the tests.

According to the FEM model (Fig. 8), only tensile stresses occur in the lower glulam flange, reaching a maximum stress value corresponding to the ultimate load of 28.7 MPa. The plywood board responds to a bending situation, with compressive stresses at the top and tensile stresses at the bottom, reaching maximum values of 14.5 and 22.1 MPa, respectively. These values are lower than the characteristic strength stated by the manufacturer in the case of the boards, but are almost 50% higher than the tensile strength stated for the lower glulam flange. The ultimate load corresponds to a maximum moment of 425.6 kNm, equivalent to that caused by a uniformly distributed load of 97.8 kN/m. Assuming a surface load value between 5.0 and 6.0 kN/m² for residential or administrative use (which includes around 1.8 kN/m² of floor self-weight), an overall safety factor between 3.91 and 2.72 would be obtained for floors with spans between 5 and 6 metres.

that the linear behaviour is maintained up to a load value of around 250.0 kN. Fig. 8 shows that this load value corresponds to maximum stresses in the concrete around 25.0 MPa, i.e. the beginning of the plasticisation phase of the concrete in accordance with its constitutive law (showed in Table 2).

In relation to the concrete, Fig. 8 shows that the area in contact with the bottom glulam flange reaches tensile values higher than its characteristic strength from the SS1 to the SS6 test. This implies that the concrete is cracked from the first stages of loading. The evolution of these cracks can be seen in Fig. 10, from the images captured with Aramis. The cracks occur from 120 mm of the section, which defines the start of the concrete section above the bottom glulam flange, and extend up to approximately 230 mm, which would correspond to the neutral fibre.

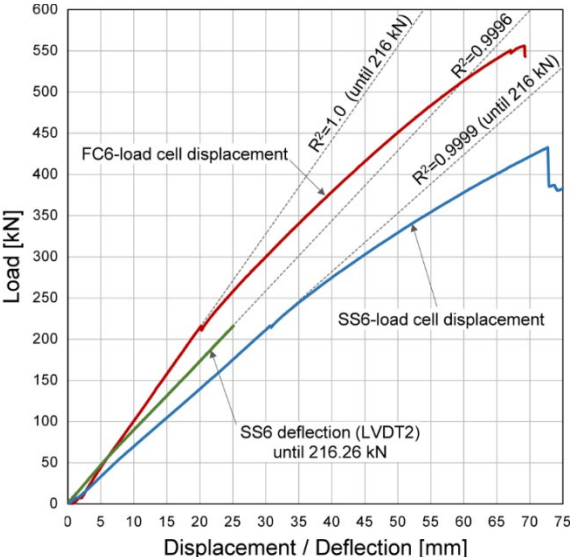
Fig.9 Deformation (LVDT 2) of the beam in test SS6 and displacement of the load crosshead during test SS6 and test FC6.

Fig. 9 shows data record corresponding to the LVDT2 sensor during the SS6 test placed at the mid-span point up to a load of 216.26 kN (beam deflection), at which point a stop is made to remove the LVDT with the aim to avoid damage as a consequence of the beam rupture. The linear regression equation corresponding to the LVDT2 record is represented in a dashed line, which shows a practically linear behaviour of the beam up to that point. The curve corresponding to the displacement measured by the load cell, also showed in Fig.9, although it does not allow precise conclusions to be drawn regarding the stiffness of the beam, shows

Fig. 9 shows the relationship between the load and the displacement of the test crosshead for test FC6, and it is evident that a stop is made when the limit load of the previous test (FC5) is reached. The figure shows a loss of linearity that coincides approximately with this point. In this case, unlike the simply supported beam, this change in behaviour should be related to the level

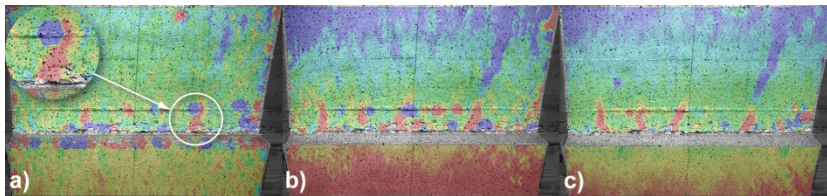
Fig. 10 Aramis images for maximum load in: a) test SS1 (43.28 kN), b) test SS5 (216.40 kN) and c) test SS6 (432.80 kN).

As indicated, both in the FEM model and in the images taken with Aramis, it can be seen that from the SS1 test, the concrete reaches stresses higher than its tensile strength in the area of contact with the lower timber flange. Despite this, the stiffness values recorded do not show any significant changes due to cracking of the concrete. This may be due, on the one hand, to the fact that the cracking is visible from the first test and, on the other hand, to the limited contribution of the tensioned concrete zone to the stiffness of the cross-section due to its proximity to the neutral axis.

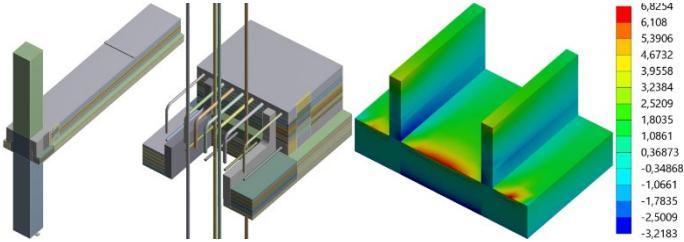
Fig. 11 Frame FEM model. Detail of the web plywood boards and the bottom glulam flange in the node area. Stress distribution in a section 180 mm from the support axis at maximum load of FC5.

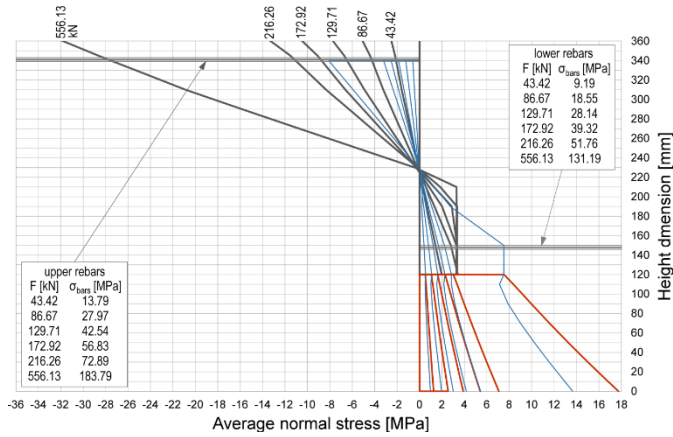
Fig. 12 Average stress distribution in the cross-section corresponding to the midspan of the frame-connected beam, obtained from the FEM model for different load values. Concrete in black, glulam bottom flange in red and web plywood boards in blue.

the resulting moments obtained from the stresses shown in Fig. 12 and Fig. 13. It can be seen that the sum of moments at the node and at the centre of the span does not correspond exactly to 100% of the isostatic moment of the simply supported beam. This can be explained by the percentage error assumed in the FEM model, which in this case does not exceed 4%, and by the linear approximation made between the section at 180 mm from the column axis and the theoretical value reached at the axis. On the other hand, it is necessary to consider the lack of continuity of the timber members in the joint area. In the case of the plywood boards, the webs are undercut to allow the passage of the reinforcement that would correspond to a transverse beam in a real situation (Fig. 2). In the case of the lower glulam flange, it is wider than the concrete support, which limits the transmission of compression to the support in this area and concentrates it in the section between the boards (Fig. 11). This way of working of the bottom flange would be more favourable in the case of central multi-span continuous beams.

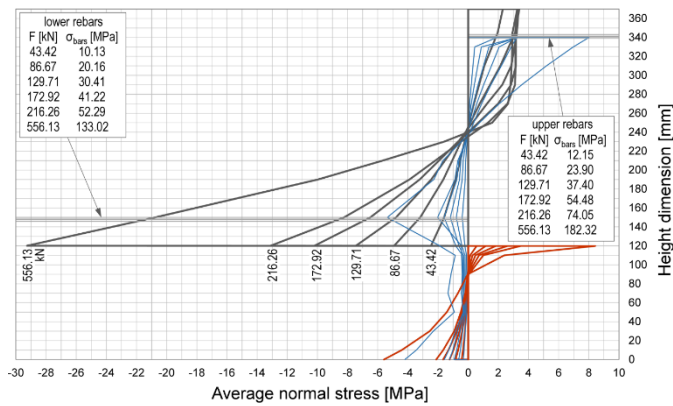
Fig. 13 Average stress distribution in the frame-connected beam in a cross-section at 180 mm from the column axis, obtained from the FEM model for different load values. Concrete in black, glulam bottom flange in red and web plywood boards in blue.

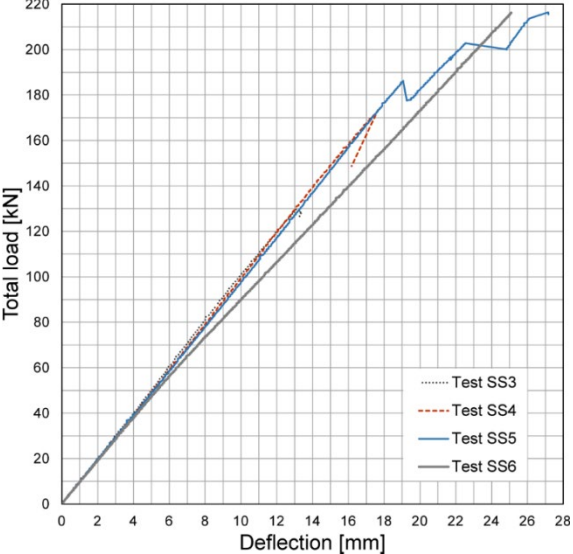
Fig. 14 Load-deflection curves (LVDT2) for different tests of the simply supported beam.

Fig. 14 shows the load-deflection curves, which relate the value of the total applied load to the deflection recorded by the LVDT2 placed at the midspan. The curves show a very linear behaviour of the beam in the successive tests. Only in the case of the SS5 test are there some singularities in the final section, which are discussed below.

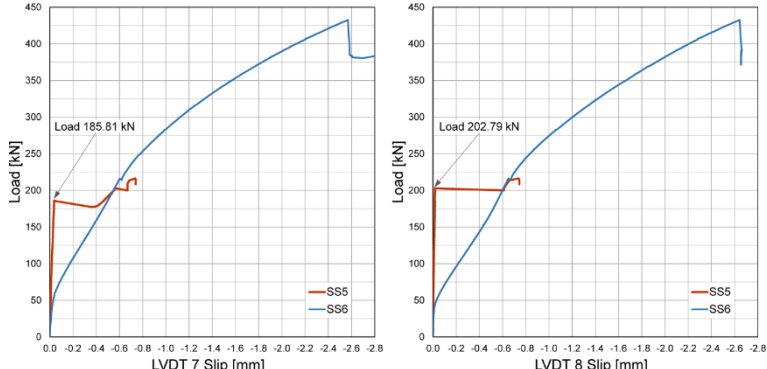
Fig. 15 Deformation recorded by a) LVDT 7 and b) LVDT8 placed on the heads of the simply supported beam.

In relation to the SS5 test, there is a first jump in the graph (Fig. 13) for a load value of 185.81 kN, with a small loss of load on the beam, and a second jump for a load of 202.79 kN. However, no external damage was observed, so the test continued up to the predicted limit load of 216.40 kN. The analysis of the records corresponding to LVDT sensors 7 and 8, placed at the heads of the beam, showed a singularity coinciding with these load values. The records of these LVDTs were coincident for tests SS1 to SS5 (Fig. 15a and Fig. 15b), with slip values that do not exceed 0.05 mm, which indicates a very rigid behaviour of the timber-concrete shear connection. Coinciding with a load value of 185.81 kN there is a sudden jump in the LVDT 7 record reaching a reading of 0.35 mm, and the same happens for a load value of 202.79 in LVDT 8, reaching a reading of 0.61 mm. Those sudden jumps cannot be associated in any case with a failure of the shear connection between the plywood boards and the concrete, since both the shear failure in the plywood board and the crushing of the concrete cylinders on the board would show a ductile behaviour [14].

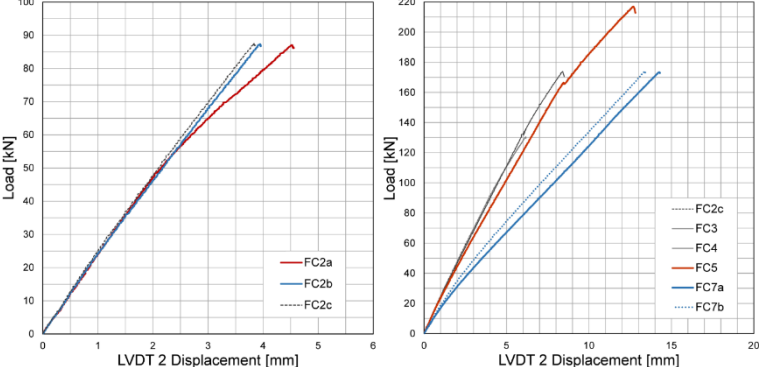
Fig. 16 Load-displacement curves (LVDT 2) of the frame-connected beam midspan for (a) tests FC2a, FC2b and FC2c and (b) tests FC2c, FC3, FC4, FC5, FC7a and FC7b.

Fig. 16a and Fig. 16b show the load-displacement curves for the frame-connected beam, relating the load applied over the beam and the displacement of the midpoint of the span. Contrary to what happened in the case of the simply supported beam, it can be seen that the curves do not have a linear behaviour along their entire length and that the slope of the curves varies throughout the successive tests.

When analysing the results of tests FC2c to FC5 (Fig. 16b), it can be seen how the load-deformation curves have an initially linear section, which tends to curve once the load value of the previous test has been exceeded. This behaviour is related to the successive opening of cracks in the tensioned concrete on the upper face of the beam-to-column node and also entails a slight loss of stiffness in the successive tests, which is evident in the slope of each curve. This aspect has also been highlighted in the analysis of the variation of the moment distribution when increasing load.

The results of the high degree of cracking reached during test FC6 are evident in the deformations recorded during tests FC7a and FC7b (Fig. 16b and Table 5). Comparing the results corresponding to tests FC5 and FC7b (both with a load of 200.0 kN on each support), an increase in deformations between 40 and 60.0% is observed. Comparing the results of tests FC7a (with no load on the supports) and FC7b, it is also observed that the effect of the load on the supports is much lower in this case than in the one observed for test FC2. Obviously, this is related to the loss of stiffness in the node, and therefore the lower incidence of the axial force on the rotation of the support in the node.

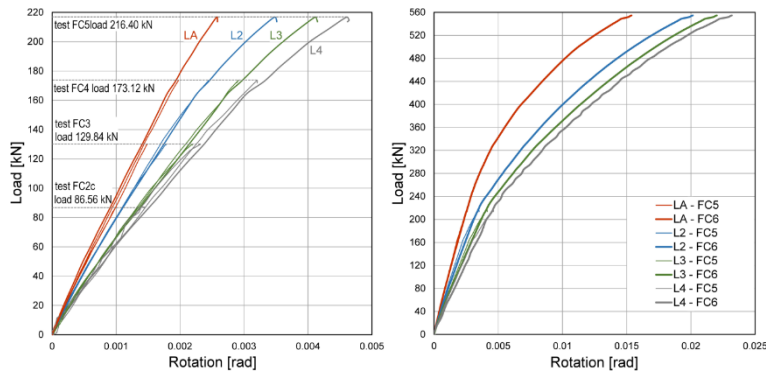
Fig. 17 Load-rotation curves a) for tests FC2 to FC5 and b) for tests FC5 and FC6.

The increase in the deformation for the successive tests FC2 to FC5 is reflected in small variations in the rotation of the sections and in the displacement of the head of the top support. From the values in Table 5, it can be seen that this rotation increase does not exceed 5%, and that it is different depending on the section considered. The variation of these rotations can be seen in Fig. 17a, which shows an appreciably linear tracing of the curves, and with not very significant differences between the successive tests. In the case of the section corresponding to the column axis (LA), the load-rotation relationship remains linear throughout the tests, while sections L2 to L4 reflect a slight curvature in the upper section with a pattern similar to that of the load-displacement curves. Fig. 17b shows the comparison between the rotation of the sections in the case of test FC5 and test FC6. In this case, it can be seen how, once again, the load-rotation relationship is practically linear up to the previous load level (216.40 kN) and how the rotation increases from that value onwards. In this case, the loss of linearity in the axis of the support can also be seen. This behaviour can be related to the cracking pattern observed in the images taken with Aramis.

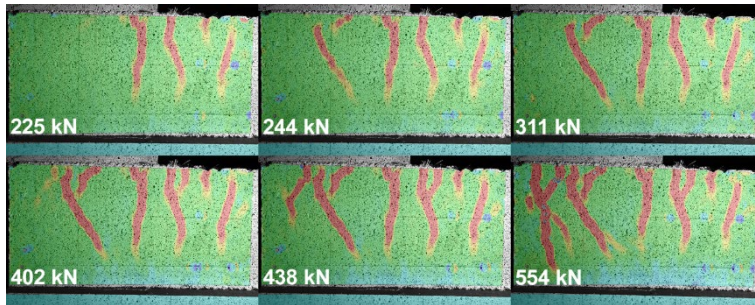
Fig. 18 Cracking evolution at the portal frame node during the FC6 test.

Fig. 18 shows the images taken with Aramis for different load milestones during the FC6 test. Up to a load of approximately 225.0 kN the cracks develop exclusively in the area of the beam adjacent to the support. For a load of approx. 244.0 kN there is clear cracking in the support area, which is reflected in the loss of linearity in the moment-rotation relationship shown in Fig. 16b and with the load-displacement relationship shown in Fig. 9.

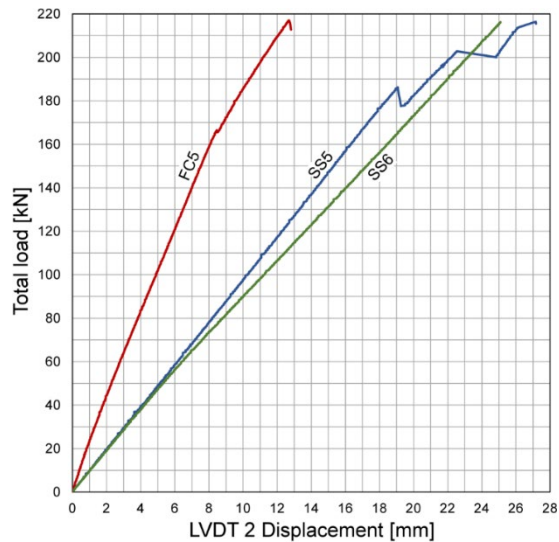
Fig. 19 LVDT2 displacements in the simply supported beam and the frame-connected beam.

The beneficial effect of the continuity of the beam connection to the supports is shown by comparing the deflection values recorded for both beams. Fig. 19 shows the LVDT 2 records for tests up to a load value of 216.40 kN. Taking as reference floor spans between 5 and 6 m and total loads between 5.0 and 6.0 kN/m², the serviceability values of distributed load on the beam would not exceed 36.0 kN/m in any case. This value would correspond to a total point load value of 155.8 kN, considering equivalent deflections for the simply supported beam, which would be below the loading milestone of the SS4 and FC4 tests. On the safety side, the results corresponding to the SS5 and FC5 tests are compared in this section. Additionally, the results corresponding to the SS6 test for the simply supported beam are included, which show the loss of stiffness explained in previous sections; despite the fact that this loss of stiffness, associated with the friction load transmission limit, has occurred for total load values higher than the service value of 155.0 kN.

Comparing the deflection results of test 5 for the frame-connected beam and the simply supported beam (FC5 and SS5), a reduction in LVDT displacement at the midpoint of the frame beam bigger than 50% is observed. This value is even higher when comparing the deflection value at the frame instead of the mid-point displacement.
