Thermal Accelerated Aging Methods for Magnet Wire: A Review

Abstract— This paper focuses on accelerated aging methods for magnet wire. Reliability of electrical devices such as coils, motors, relays, solenoids and transformers is heavily dependent on the Electrical Insulation System (EIS). Accelerated aging methods are used to rapidly simulate the conditions in real life, which is typically years (20,000 hours) depending on the operating conditions. The purpose of accelerated aging is to bring lifetime of an EIS to hours, days or weeks. Shortening the lifetime of an EIS to such an extent, allows for the study of the insulation materials behavior as well as investigate ways to estimate the remaining useful life (RUL) for the purpose of predictive maintenance. Unexpected failures in operation processes, where redundancy is not present, can lead to high economical losses, machine downtime and often health and safety risks. Conditions, under which thermal aging methods are generally reported in the literature, typically neglect other factors, owing to the sheer complexity and interdependence of the multifaceted aging phenomena. This paper examines some existing thermal aging tests, wh

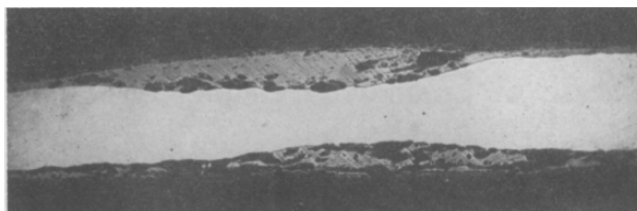
Fig. 1. Copper oxidation under enamel layer [3]

This reduces cross sectional area and increases the resistance of a conductor see Fig. 1. It also leads to an increase in the heat generation which in turn further accelerates the oxidation process [3]. The oxidation rate on the EIS depends on an enamel and temperatures involved. Experiments conducted by Petitgas et al. [4] presented on Fig. 2, show relative weight stability of an insulation at lower temperatures. Accordingly, the weight loss rate increases respectively with the temperature, however we can observe that once a critical point is reached, rapid degradation takes place which causes the pyrolysis of the EIS. Moreover, this will happen regardless, even if the EIS were to be placed within an inert atmosphere. However, this critical point for an inert atmosphere is higher [4].

The aging of the copper itself may have a substantial influence on EIS measurements during aging process. It was described in [3] where significant changes were found. A longitudinal cut of an enamelled wire after aging was shown in Fig. 1, indicating copper oxidation under enamel. It was stated, that temperatures over 200 °C has a serious impact on copper conductors, especially when there are more impurities present in the copper [3]. It is likely that this copper oxide layer will have an impact on the measured capacitance and insulation resistance due to chemical changes present in the specimens. Reducing the cross-sectional area would lead to local hotspots and further more increase copper oxidation speed [3]. Over time this could significantly increase the temperature levels above EIS rated class and thus would cause the premature failure of the insulation.

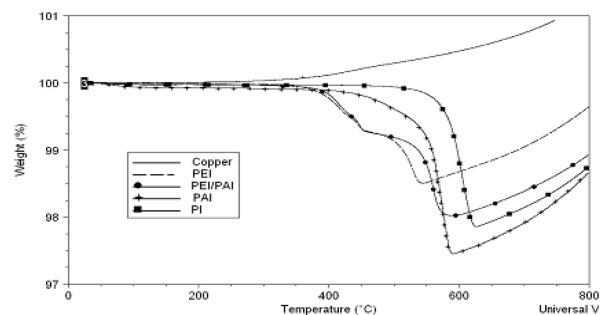
Fig. 2. Thermogravimetry (TG) curves of enameled wire and copper under air [4]

Weight loss of EIS using thermogravimetry was conducted by Petitgas et al. which was presented in Fig. 2, shows the effects of elevated temperatures on different EIS materials. High temperatures cause the evaporation of enamels at certain temperatures and even pyrolysis to occur [4]. Dielectric loss of tested wire samples is apparent from Fig. 3. showing the increases in Tan Delta [4]. The theory would suggest that the aging of the polymeric enamels should result in an overall decrease of in the measured enamel capacitance. Capacitance decrease as a result of aging was presented in [16]. However as seen on Fig. 5 and Fig. 6 from [5], which follows the IEC 60851-5 standard procedure, capacitance was shown to increase in value during the aging process. This is very contradicting result which should be further verified. The difference could be as a result of different aging conditions.

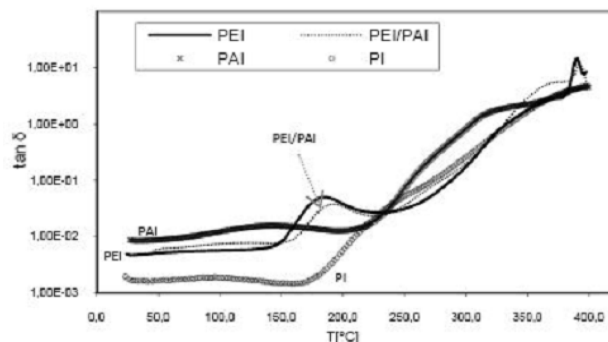
Fig. 3. Dielectric loss factor from room temperature to 400 °C under N₂ atmosphere at 1 kHz [4]

Elevated temperatures may also have a post curing effect on enamels and cause a shifting of the dielectric relaxation phenomena within certain materials [12-14]. Dielectric relaxation spectroscopy results are shown on Fig. 3. Glass transition temperature within an enamel increases with aging time and temperature value respectively. This will have an effect on the mechanical properties of an enamel [4], changes to the temperature alone, results in changes of the material properties such as ductility, elongation and volume increase due to heat expansion.

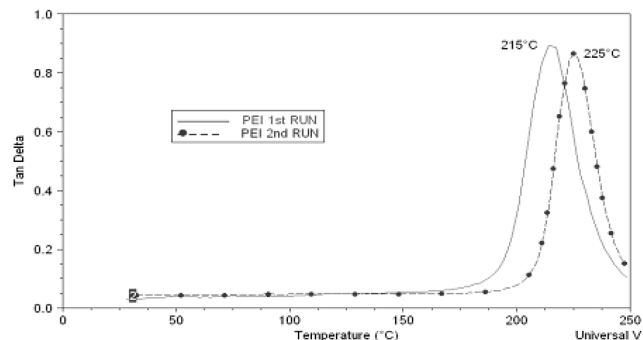
Fig. 4. Dynamic Mechanical Analysis presenting post curing change [4]

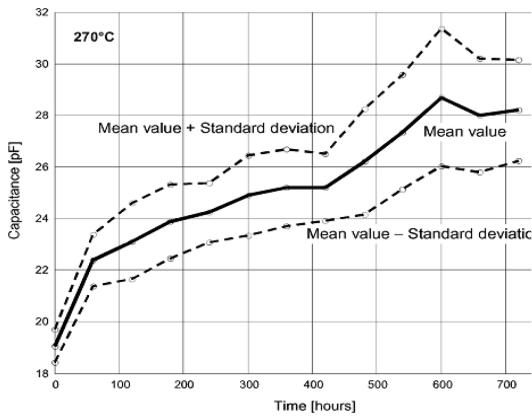
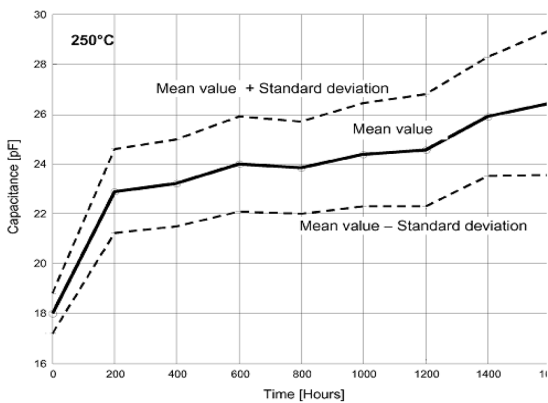
Fig. 5. Capacitance change during thermal aging of twisted pairs [5]

Fig. 6. Capacitance change during thermal aging of twisted pairs [5]

Sumislawska et al. [16] presents a nonlinear decrease of capacitance on tested specimens Fig. 7, however Savin et al. [17], [18] and Werynski et al. [5] showed, that insulation capacitance is increasing during the thermal aging process with 12 cycles (Fig. 5 and Fig. 6). Their work incorporated the IEC 60216-1, 2 and 3 standards in the experimental design.

Sumislawska et al. [16] stated, that delaminating insulation was observed at 800h of aging under temperature of 230 °C. In Werynski et al. [5] experiment (Fig. 5 and Fig. 6), unusual capacitance change occurred between 600h and 800h, which was not explained. These results combined with copper oxidation described in [3], could lead to conclusion, that copper oxidation layer was formed and caused delaminating of enamel. Starting at 600h for over 200 °C temperature of exposure. Since measurement of capacitance wasn't done for 600h in [16] (Fig. 7), but capacitance trend did not change significantly from 800h onwards, hence only assumptions for this event can be made. Closer inspection of this change should be made and establish whenever it has or has not impact on insulation aging. Delaminating of an insulation could have significant impact on the other TEAM stresses and promote their effects.

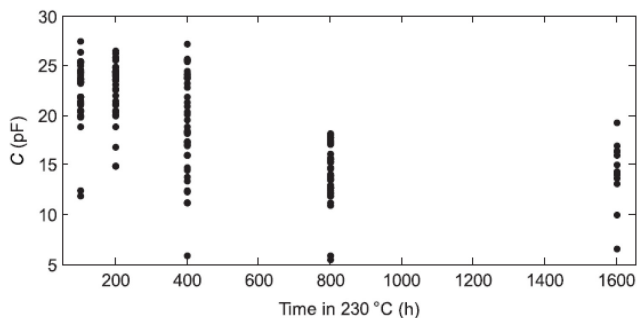
Fig. 7. Capacitance as function of time for insulation aged in 230 °C [16]
